Channel Stability Problems, Pajaro River, Watsonville and Pajaro, California

**U.S. Army Engineer Committee on Channel
Stabilization Report of the 63rd Meeting**

Ronald R. Copeland and Dinah N. McComas, editors

August 2000

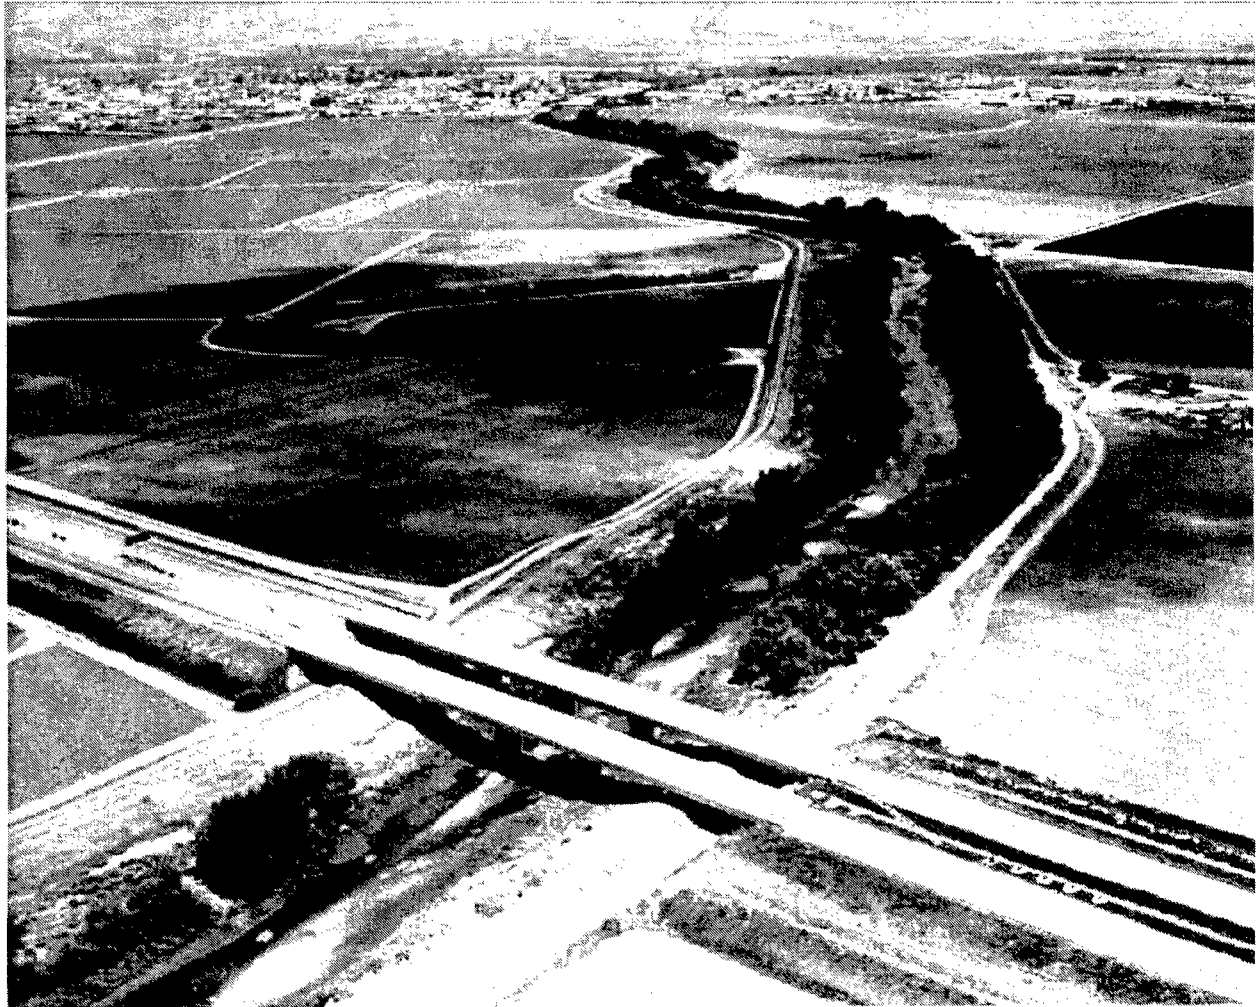
Plate 3
Aerial View of Project at Highway 1, June 1971

on Plate 2 shows a footprint of the levee project, the photograph on Plate 3 (dated June 1971) shows an aerial view of the project at Highway 1.
